**Flood Control Project Maintenance
Levee Inspections**

Maintenance Issue Types Only, Levee Inspection Report By Mile - Spring 2018

Reclamation District No. 0524 Middle Roberts Island

Waterway	Bank	Unit Miles	Inspection Start/End	Inspector
Unit No. 01 San Joaquin River	Left	6.20	04/24/2018 04/24/2018	Richard Willoughby

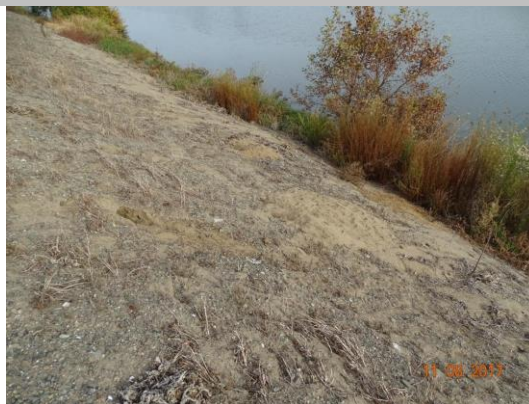
Photo 1 of 1 : SP_2018_RD0524_107_237_20180323_00348.jpg

Looking northwest at the waterside slope.

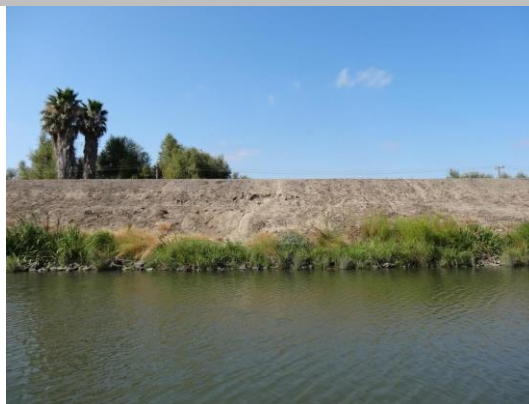
Photo 1 of 3 : SP_2018_RD0524_107_1_20180323_00001.jpg

LM Start	0.19	Rating **	U	Issue No.	1
LM End	0.19	Issue Type +	Ma	Location *	WS
Category	Supplemental			GPS Latitude/Longitude	
				Start	End
Item	DWR Erosion Survey			37.939085 °	37.939085 °
				-121.343917 °	-121.343917 °
DWR ID	RD0524U01RM40.85				
Comment Code					
Inspector Comment					
09/13/2017: No significant change observed.					
07/25/2016: No significant change observed.					
06/24/2015: No significant change observed.					
06/19/2014: No significant change observed.					
08/13/2013: The erosion was discovered during 2013 spring levee inspection. Inspector comment: Erosion is located along the lower level of water-ward slope. [2017 Site ID:RD0524U01RM40.85]

Close view of the erosion.

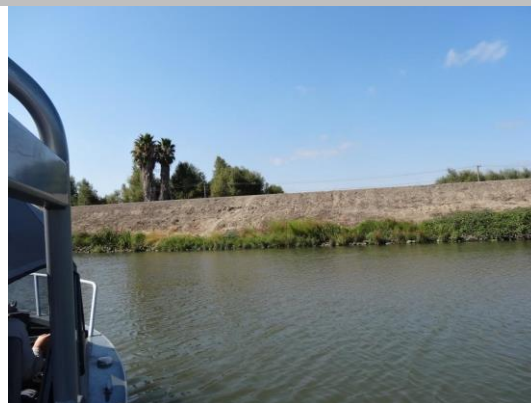
Photo 2 of 3 : SP_2018_RD0524_107_1_20180323_00002.jpg

LM Start	0.19	Rating **	U	Issue No.	1 (cont)	
LM End	0.19	Issue Type +	Ma	Location *	WS	
Category	Supplemental			GPS Latitude/Longitude		
				Start		End
Item	DWR Erosion Survey			37.939085 °		37.939085 °
				-121.343917 °		-121.343917 °
DWR ID	RD0524U01RM40.85					
Comment Code						
Inspector Comment						
09/13/2017: No significant change observed.						
07/25/2016: No significant change observed.						
06/24/2015: No significant change observed.						
06/19/2014: No significant change observed.						
08/13/2013: The erosion was discovered during 2013 spring levee inspection. Inspector comment: Erosion is located along the lower level of water-ward slope. [2017 Site ID:RD0524U01RM40.85]

Front view of the erosion.

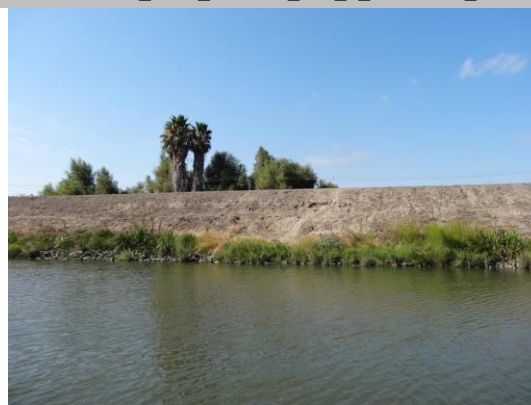
Photo 3 of 3 : SP_2018_RD0524_107_1_20180323_00003.jpg

Front view of the erosion.

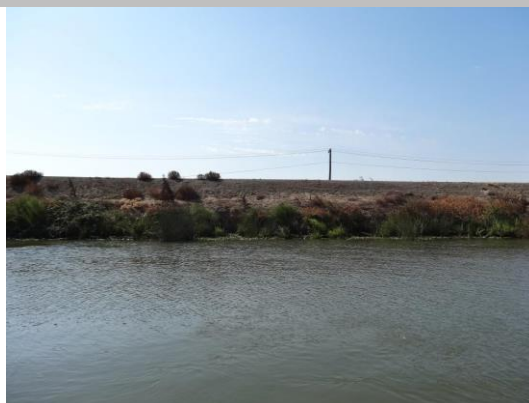
Photo 4 of 4 : SP_2018_RD0524_107_2_20180323_00007.jpg

Front view of the erosion.

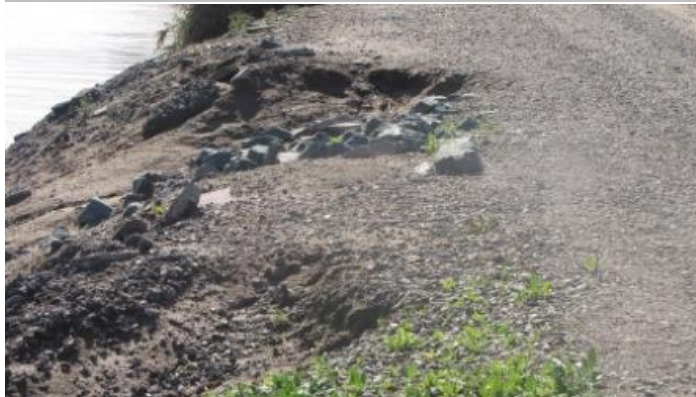
Photo 2 of 4 : SP_2018_RD0524_107_13_20180323_00025.jpg

LM Start	0.64	Rating **	M	Issue No.	13 (cont)
LM End	0.65	Issue Type +	Ma	Location *	WS
Category	Earthen Levee			GPS Latitude/Longitude	
				Start	End
Item	Slope Stability			37.938105 °	37.938023 °
				-121.336288 °	-121.336173 °
DWR ID	DWR_RD0524_01_s_2012_13				
Comment Code					
S1 : Repair slope instability.					
Inspector Comment					
Depression extends from shoulder to mid levee slope two site with this section.

Looking south at erosion on waterside shoulder.

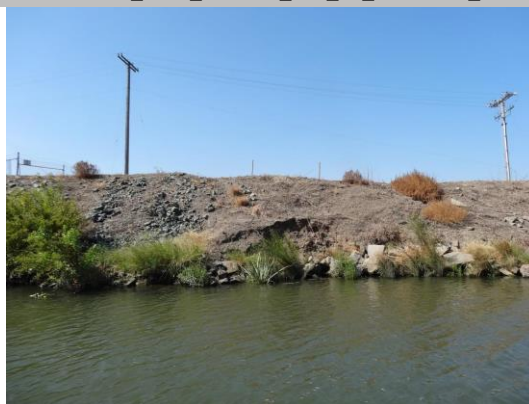
Photo 2 of 4 : SP_2018_RD0524_107_16_20180323_00034.jpg

Close view of the erosion.

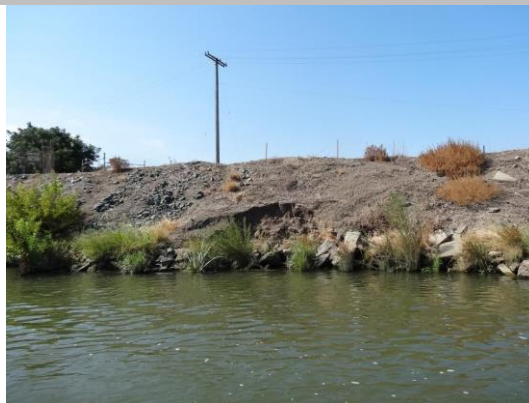
Photo 4 of 4 : SP_2018_RD0524_107_16_20180323_00036.jpg

Close view of the erosion.

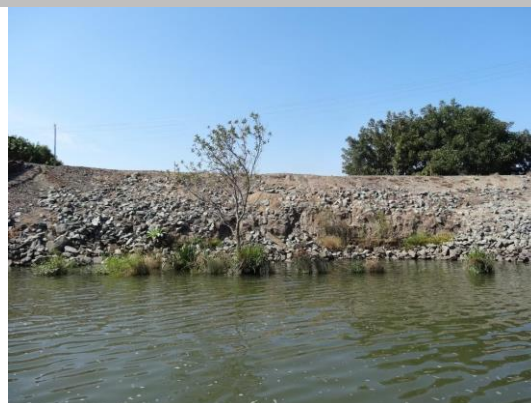
Photo 3 of 3 : SP_2018_RD0524_107_17_20180323_00039.jpg

LM Start	0.71	Rating **	M	Issue No.	17 (cont)	
LM End	0.73	Issue Type +	Ma	Location *	WS	
Category	Supplemental			GPS Latitude/Longitude		
				Start		End
Item	DWR Erosion Survey			37.937222 °		37.937222 °
				-121.335277 °		-121.335277 °
DWR ID	RD0524U01RM41.36					
Comment Code						
Inspector Comment						
09/13/2017: No significant change observed.						
07/25/2016: No significant change observed.						
06/24/2015: The erosion site is immediately downstream of the RR bridge. [2017 Site ID:RD0524U01RM41.36]

Close view of the erosion.

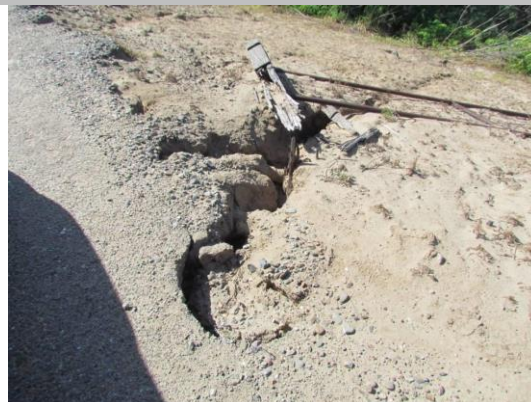
Photo 1 of 2 : SP_2018_RD0524_107_157_20180323_00221.jpg

LM Start	0.72	Rating **	U	Issue No.	157
LM End	0.72	Issue Type +	Ma	Location *	LS
Category	Earthen Levee			GPS Latitude/Longitude	
				Start	End
Item	Erosion / Bank Caving			37.937290 °	37.937290 °
				-121.335417 °	-121.335417 °
DWR ID	DWR_RD0524_01_s_2017_157				
Comment Code					
Inspector Comment					
Slope damage caused by rain runoff on landside slope.

Looking west at slope damage caused by rain runoff on landward slope.

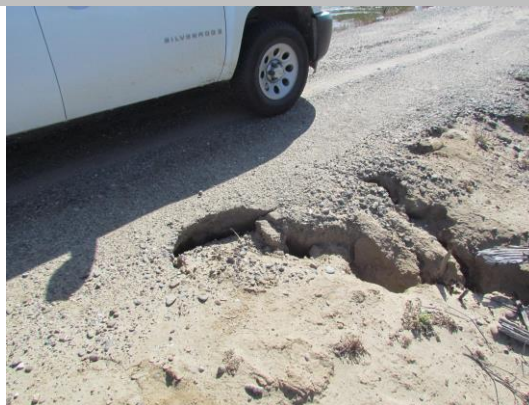
Photo 2 of 2 : SP_2018_RD0524_107_157_20180323_00222.jpg

LM Start	0.72	Rating **	U	Issue No.	157 (cont)	
LM End	0.72	Issue Type +	Ma	Location *	LS	
Category	Earthen Levee			GPS Latitude/Longitude		
				Start		End
Item	Erosion / Bank Caving			37.937290 °		37.937290 °
				-121.335417 °		-121.335417 °
DWR ID	DWR_RD0524_01_s_2017_157					
Comment Code						
Inspector Comment						
Slope damage caused by rain runoff on landside slope.

Looking south at slope damage caused by rain runoff on landward slope.

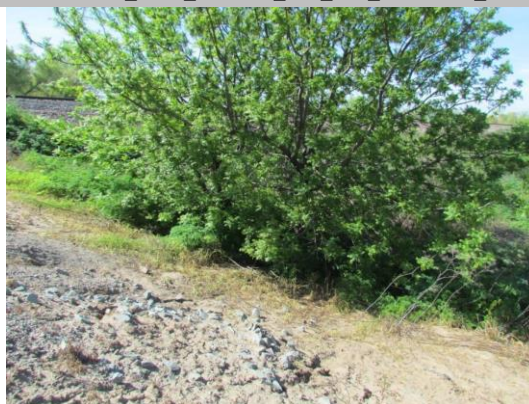
Photo 2 of 2 : SP_2018_RD0524_107_156_20180323_00220.jpg

Looking west at dense untrimmed tree on landward slope.

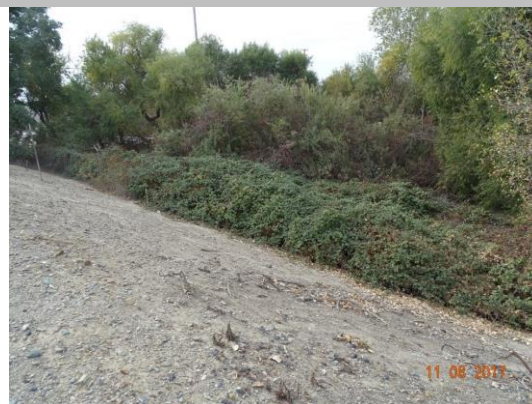
Photo 1 of 3 : SP_2018_RD0524_107_262_20180323_00364.jpg

LM Start	0.75	Rating **	U	Issue No.	262
LM End	0.78	Issue Type +	Ma	Location *	LS
Category	Earthen Levee			GPS Latitude/Longitude	
				Start	End
Item	Vegetation			37.936813 °	37.936539 °
				-121.335019 °	-121.334863 °
DWR ID	DWR_RD0524_01_s_2012_262				
Comment Code					
V2 : Remove the wild growth other than native grasses from the levee slopes.					
Inspector Comment					
Dense vegetation at landside toe along fence line.

Looking northeast at the landside slope.

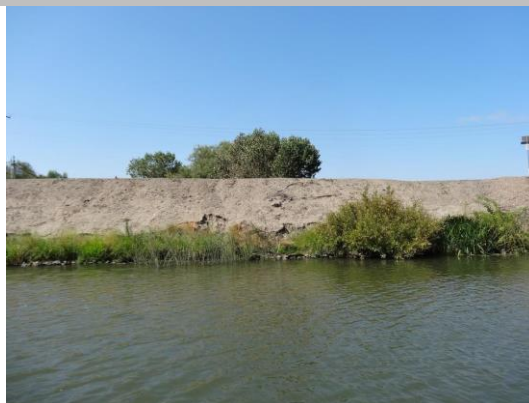
Photo 2 of 4 : SP_2018_RD0524_107_21_20180323_00049.jpg

Front view of the erosion site. Vegetation is visible.

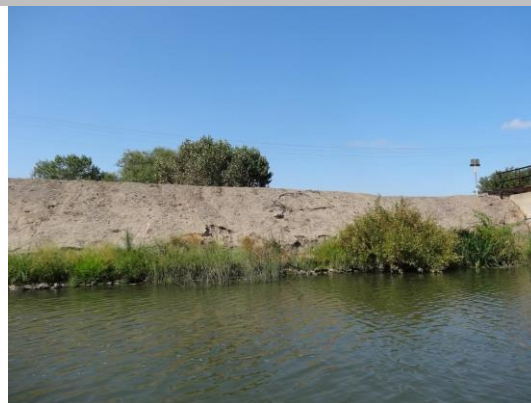
Photo 3 of 4 : SP_2018_RD0524_107_21_20180323_00050.jpg

Front view of the erosion.

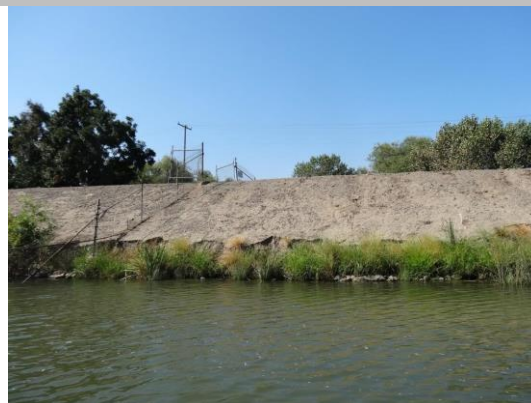
Photo 4 of 4 : SP_2018_RD0524_107_21_20180323_00051.jpg

Front view of the erosion.

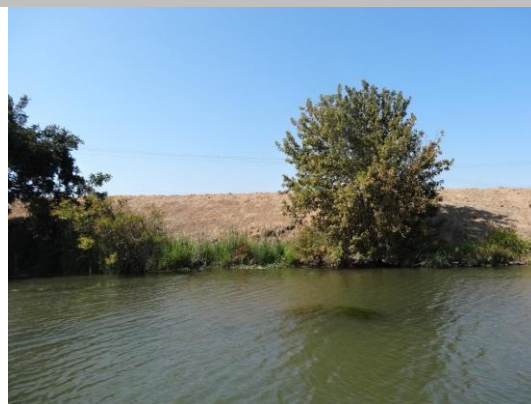
Photo 1 of 2 : SP_2018_RD0524_107_22_20180323_00052.jpg

LM Start	0.83	Rating **	U	Issue No.	22
LM End	0.84	Issue Type +	Ma	Location *	WS
Category	Supplemental			GPS Latitude/Longitude	
				Start	End
Item	DWR Erosion Survey			37.935930 °	37.935930 °
				-121.334133 °	-121.334133 °
DWR ID	RD0524U01RM41.44				
Comment Code					
Inspector Comment					
09/13/2017: No significant change observed.					
07/25/2016: No significant change observed.					
06/24/2015: No significant change observed.					
06/19/2014: No significant change observed.					
08/13/2013: Site was discovered during boat survey. The dense vegetation blocks a clear view of the erosion. Size of erosion site was very roughly estimated. [2017 Site ID:RD0524U01RM41.44]

Front view of the erosion. The tree and vegetation block the view of the site.

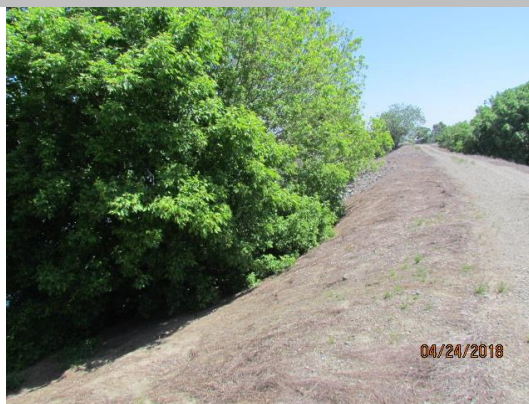
Photo 1 of 1 : SP_2018_RD0524_107_149_20180427_00489.jpg

Looking southeast at untrimmed trees on waterward slope. (Spring 2018)

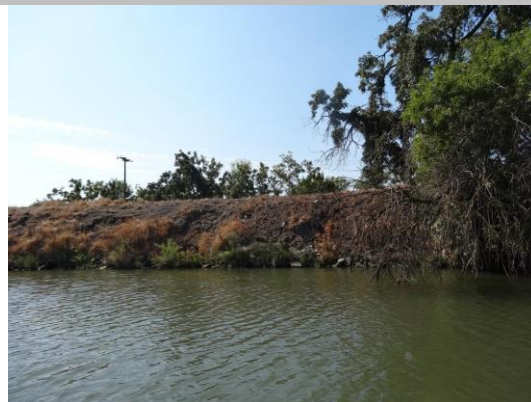
Photo 4 of 4 : SP_2018_RD0524_107_30_20180323_00068.jpg

Downstream view of the erosion.

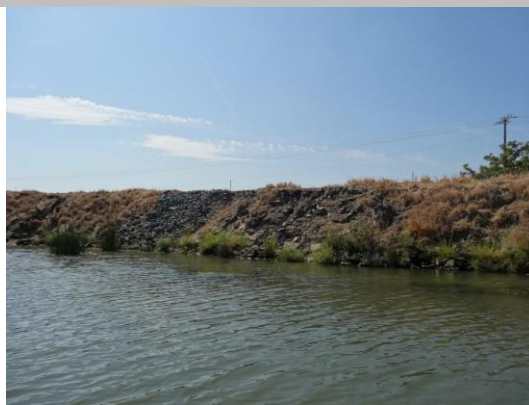
Photo 1 of 3 : SP_2018_RD0524_107_33_20180323_00075.jpg

Upstream view of the site.

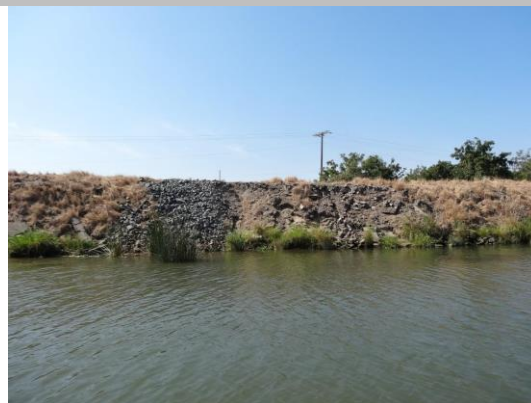
Photo 3 of 3 : SP_2018_RD0524_107_33_20180323_00077.jpg

Front view of the site.

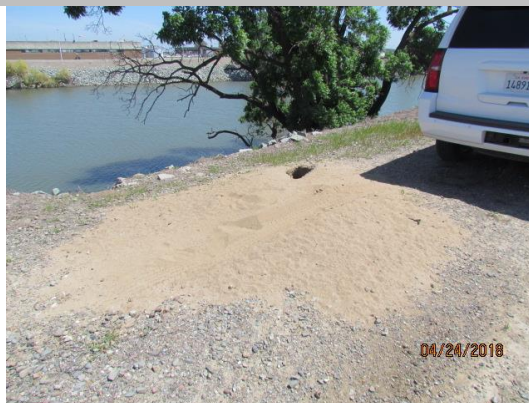
Photo 3 of 3 : SP_2018_RD0524_107_150_20180427_00495.jpg

Looking southeast at large rodent hole on waterward shoulder. (Spring 2018)

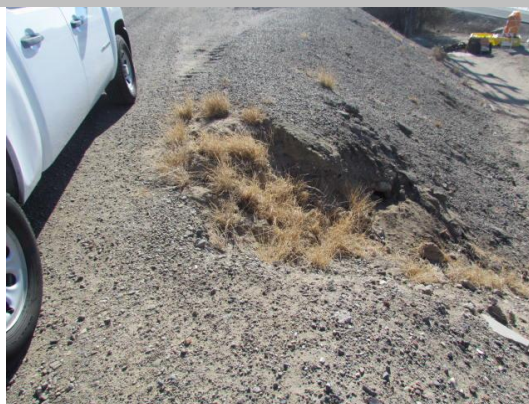
Photo 1 of 2 : SP_2018_RD0524_107_18_20180323_00040.jpg

Looking south at caving on landward shoulder. (Fall 2015)

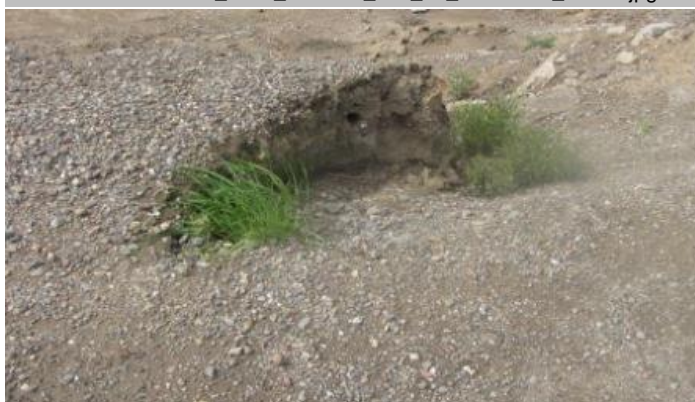
Photo 2 of 2 : SP_2018_RD0524_107_18_20180323_00046.jpg

Updated view from above the slope stability.

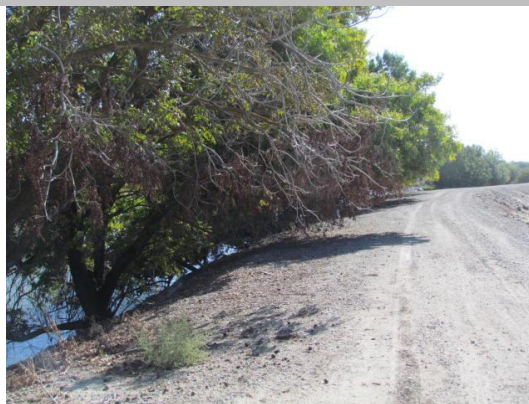
Photo 1 of 1 : SP_2018_RD0524_107_19_20180323_00047.jpg

Looking southeast at low hanging tree branches at waterside toe.

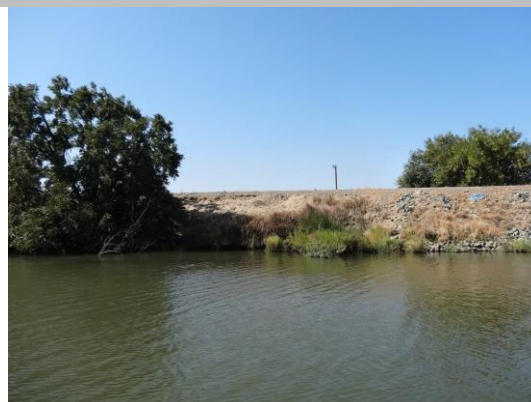
Photo 2 of 4 : SP_2018_RD0524_107_44_20180323_00095.jpg

Direct view of the site.

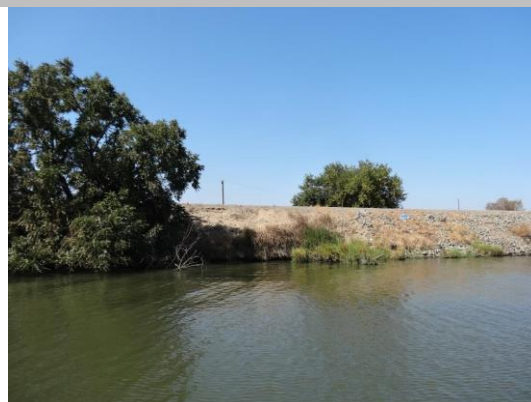
Photo 4 of 4 : SP_2018_RD0524_107_44_20180323_00097.jpg

View of the site. Note the tree near the erosion site.

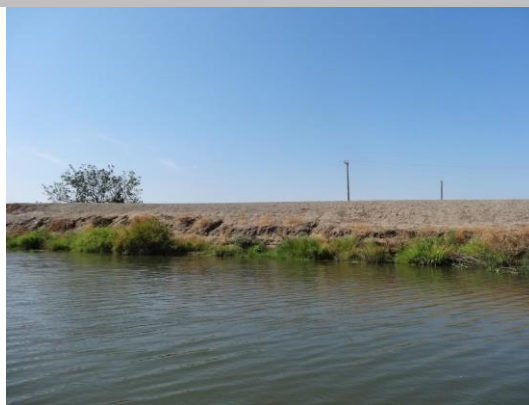
Photo 1 of 4 : SP_2018_RD0524_107_47_20180323_00105.jpg

Front view of the erosion.

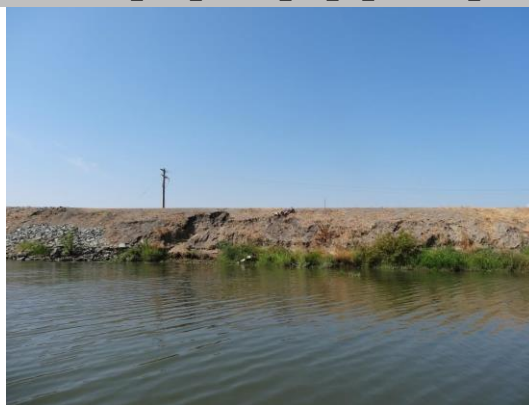
Photo 3 of 4 : SP_2018_RD0524_107_47_20180323_00107.jpg

Close view of the erosion.

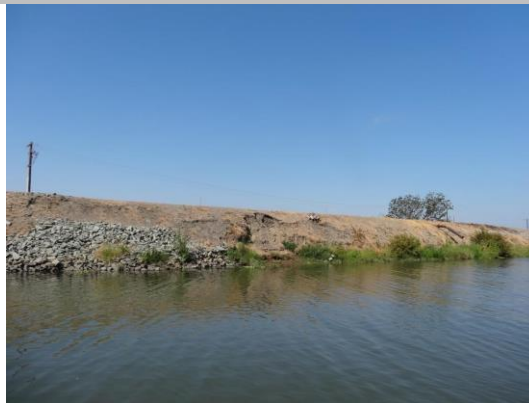
Photo 4 of 4 : SP_2018_RD0524_107_47_20180323_00108.jpg

Front view of the erosion. Note the worsen erosion next to the protected slope.

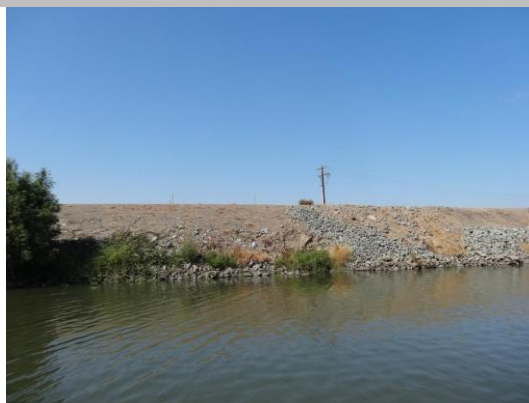
Photo 2 of 2 : SP_2018_RD0524_107_55_20180323_00118.jpg

Front view of the erosion.

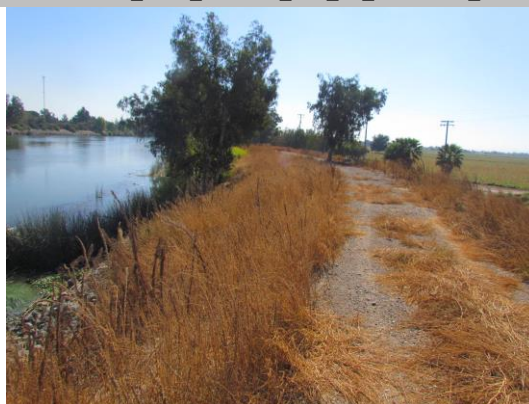
Photo 3 of 3 : SP_2018_RD0524_107_25_20180323_00056.jpg

Looking southwest at dense veg on waterward slope.

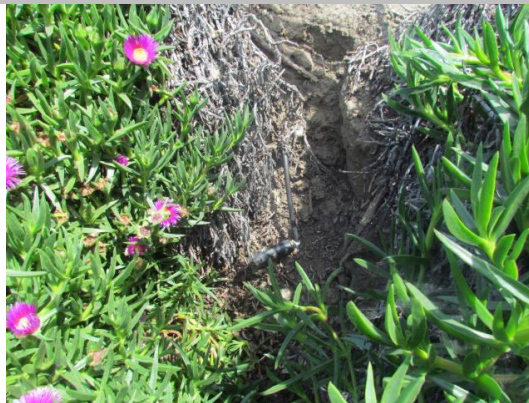
Photo 2 of 2 : SP_2018_RD0524_107_176_20180323_00244.jpg

Looking east at erosion within landscaping on landward slope and shoulder.

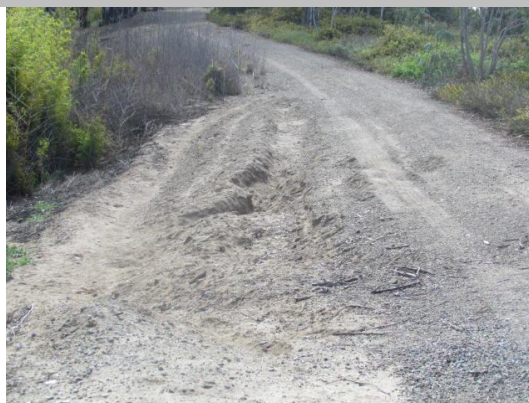
Photo 4 of 4 : SP_2018_RD0524_107_31_20180323_00072.jpg

Looking south slope damage on waterward shoulder and slope.

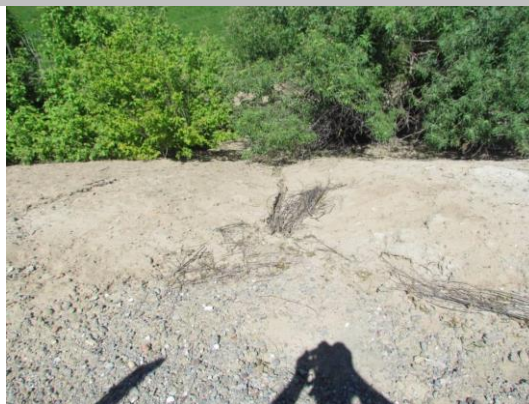
Photo 1 of 1 : SP_2018_RD0524_107_160_20180323_00224.jpg

Looking east at erosion caused by rain runoff on waterward slope.

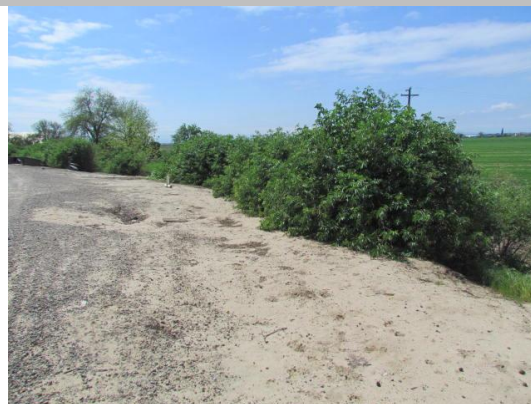
Photo 1 of 1 : SP_2018_RD0524_107_40_20180323_00089.jpg

Looking southwest at dense veg on landward slope.

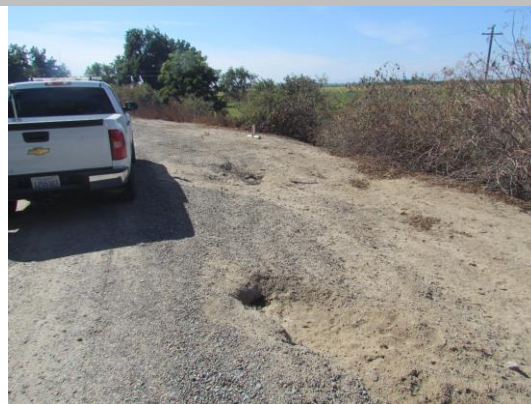
Photo 1 of 2 : SP_2018_RD0524_107_82_20180323_00165.jpg

Looking southwest at large holes on landward slope. (Fall 2016)

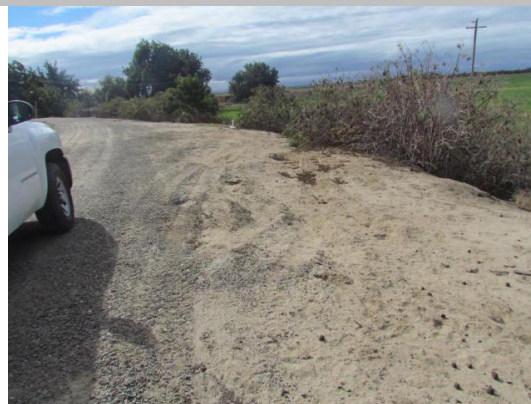
Photo 2 of 2 : SP_2018_RD0524_107_82_20180323_00166.jpg

Looking southwest at damaged landward slope. (Spring 2016)

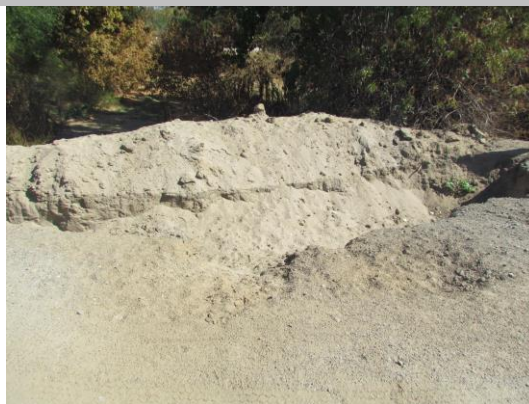
Photo 1 of 3 : SP_2018_RD0524_107_218_20180323_00300.jpg

Looking east at trench on waterward shoulder.

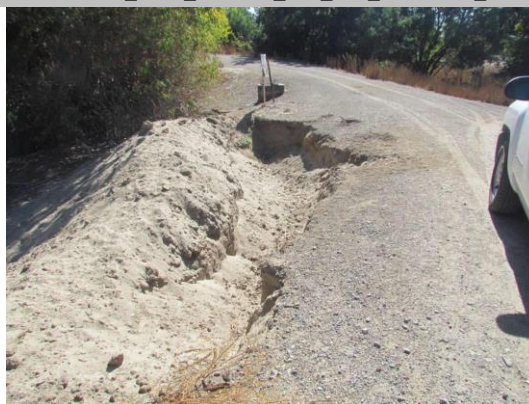
Photo 3 of 3 : SP_2018_RD0524_107_218_20180323_00302.jpg

Looking south at trench on waterward shoulder.

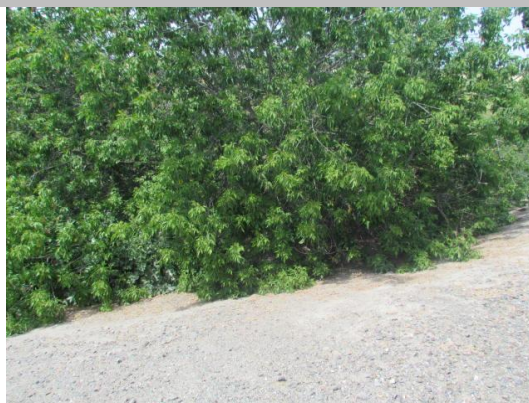
Photo 2 of 2 : SP_2018_RD0524_107_51_20180323_00114.jpg

Looking south at dense trees on landward slope spring 2015

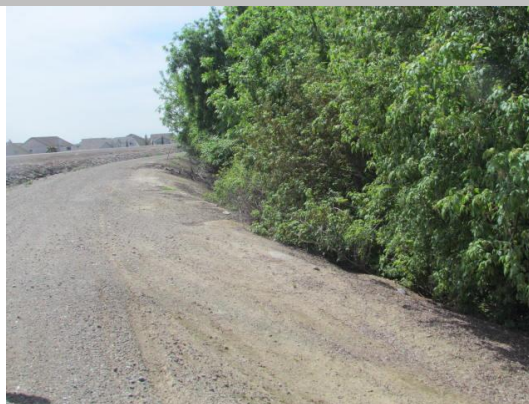
Photo 1 of 1 : SP_2018_RD0524_107_57_20180323_00122.jpg

Looking south at dense trees on landward slope.

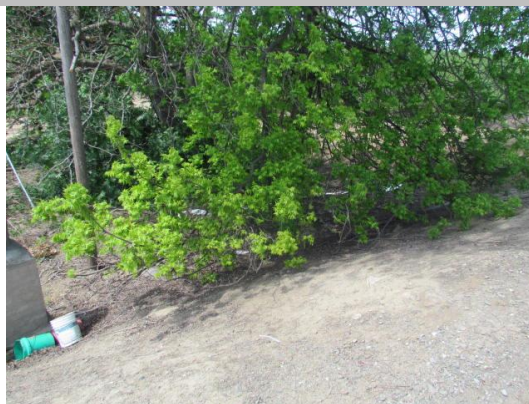
Photo 1 of 1 : SP_2018_RD0524_107_61_20180323_00130.jpg

Looking east at untrimmed tree at landward toe.

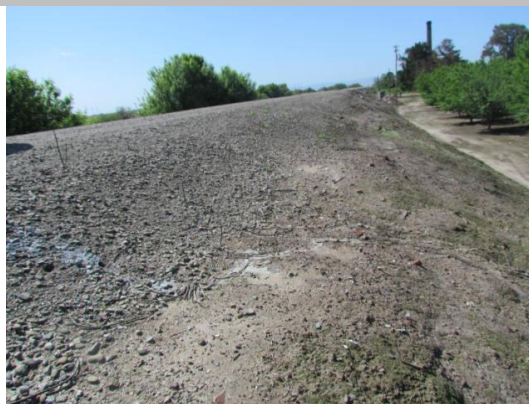
Photo 1 of 3 : SP_2018_RD0524_107_108_20180323_00190.jpg

Looking north at caving slope on landside of levee.

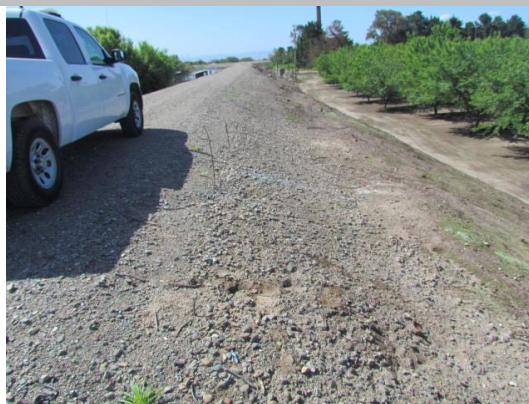
Photo 2 of 3 : SP_2018_RD0524_107_108_20180323_00191.jpg

Looking south at damage slope on landside of levee.

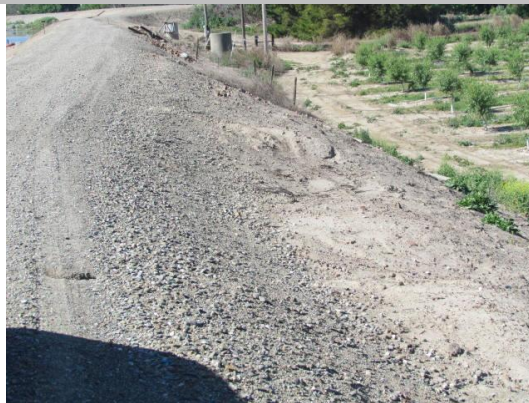
Photo 3 of 3 : SP_2018_RD0524_107_108_20180323_00192.jpg

Looking southwest at caving slope on landside of levee. (Spring 2014)

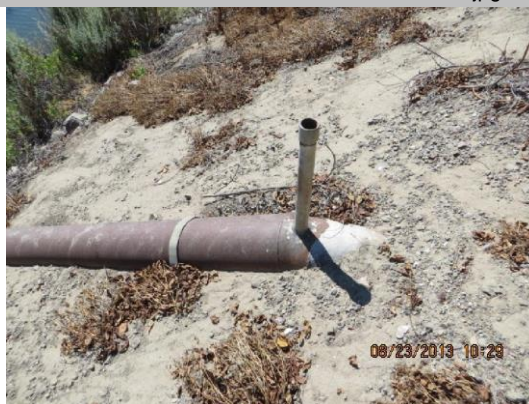
Photo 2 of 3 : UCIP_SP_2018_51633_30688.jpg

Vent on pipe on WS slope. Possible slurry standpipe that has not yet been used.

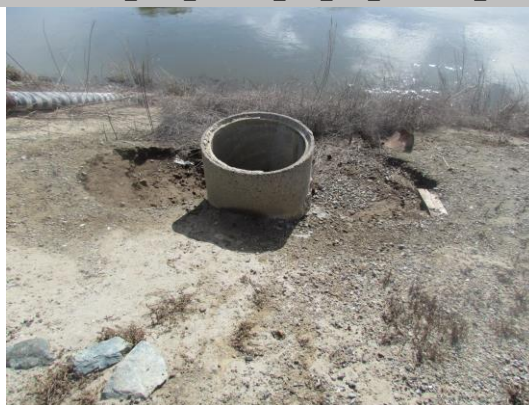
Photo 3 of 3 : SP_2018_RD0524_107_183_20180323_00258.jpg

Looking east at erosion on waterward slope.
